MSC-04112

APOLLO 14 MISSION REPORT

MANNED SPACECRAFT CENTER

MAY 1971

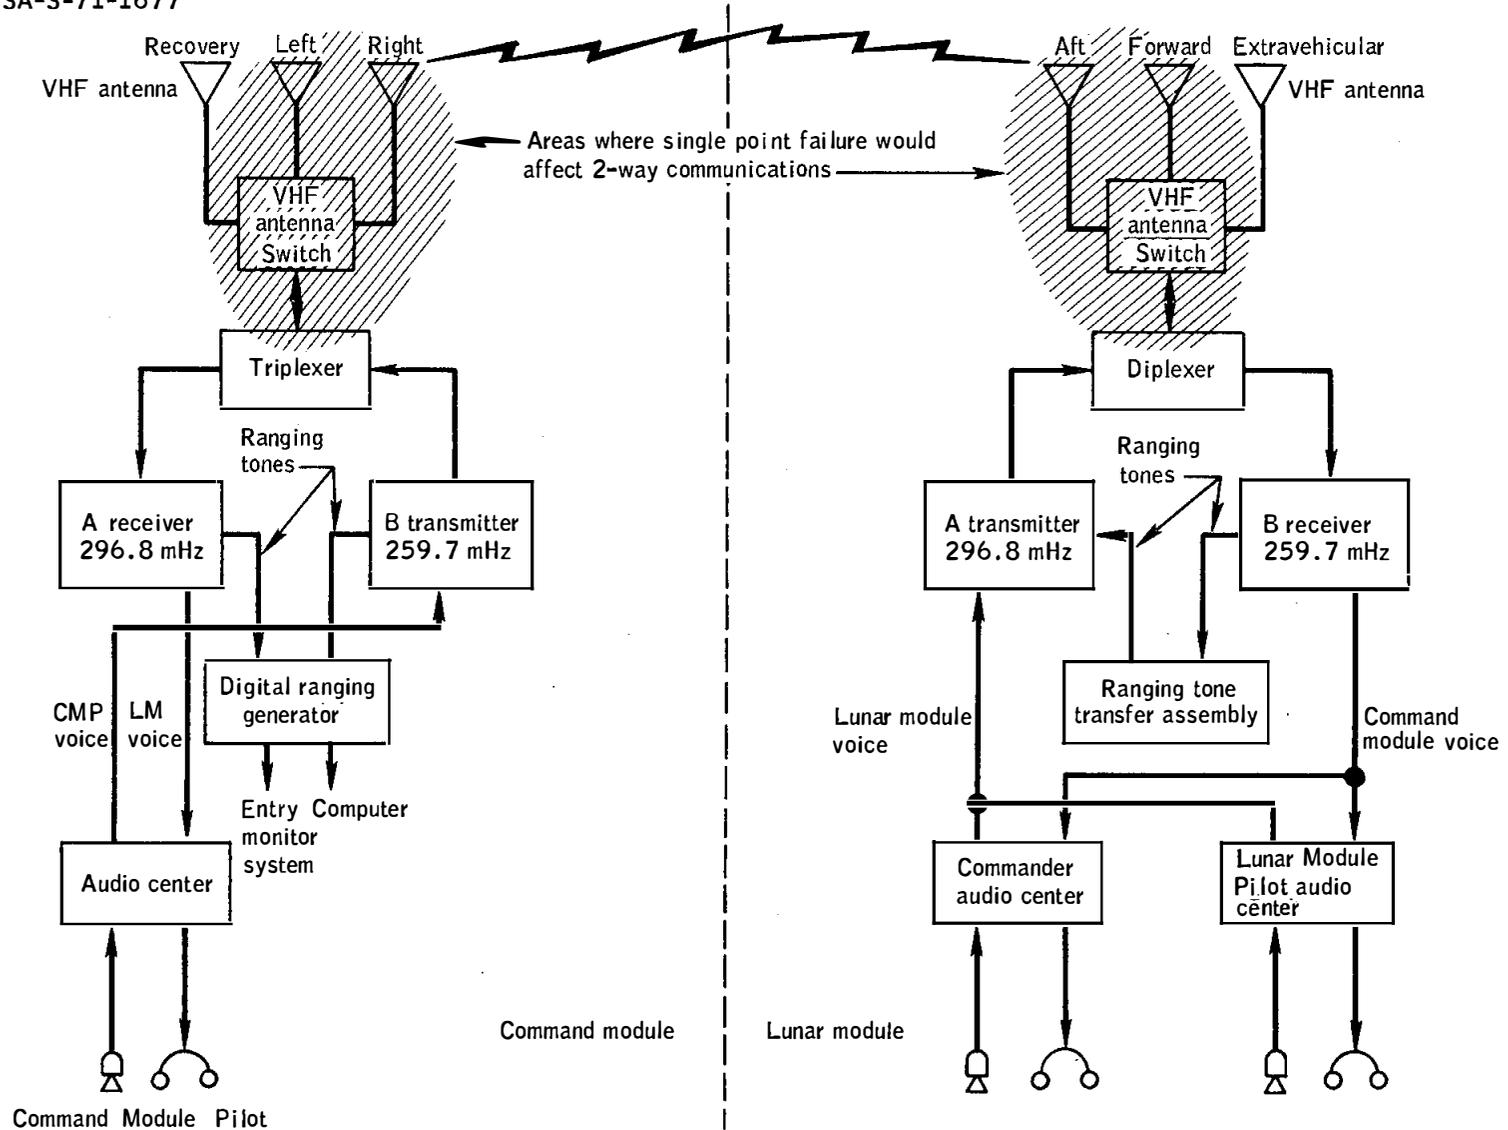
Figure 14-9.- Block diagram of VHF communications systems.

The lower-than-normal RF link performance was a two-way problem (voice was poor in both directions); therefore, certain parts of the VHF system are prime candidates for the cause of the problem. Figure 14-9 is a block diagram of the VHF communications system as configured during the rendezvous phase of the mission. Also shown are those areas in which a malfunction could have affected the two-way RF link performance. A single malfunction in any other area would have affected one-way performance only.

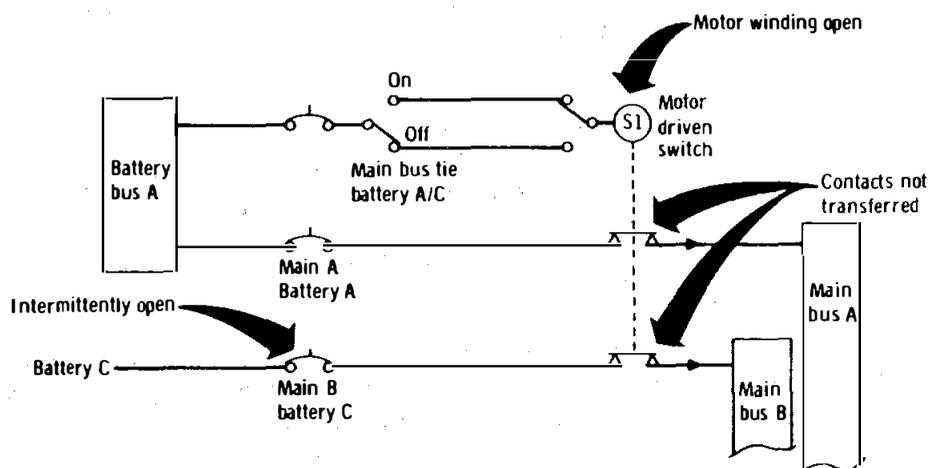
Figure 14-10.- Bus-tie circuitry.

During entry, when the main bus tie switches (motor-driven switches) were placed in the off position at 800 feet, main bus A should have de-energized; however, the bus remained on until after landing when the battery bus-tie circuit breakers were opened. Postflight testing showed that the main motor switch contacts were closed (fig. 14-10). Also, the

internal switches which control the drive motor were shorted together and the motor windings were open. These conditions indicate that the motor switch stalled.

The motor switch failure discussed in section 14.1.6 should have resulted in main buses A and B being energized after the motor switch was commanded open (fig. 14-10). Postflight continuity checks, however, showed that there was an open circuit between battery C and main bus B and that the main bus B circuit breaker for battery C was intermittent.

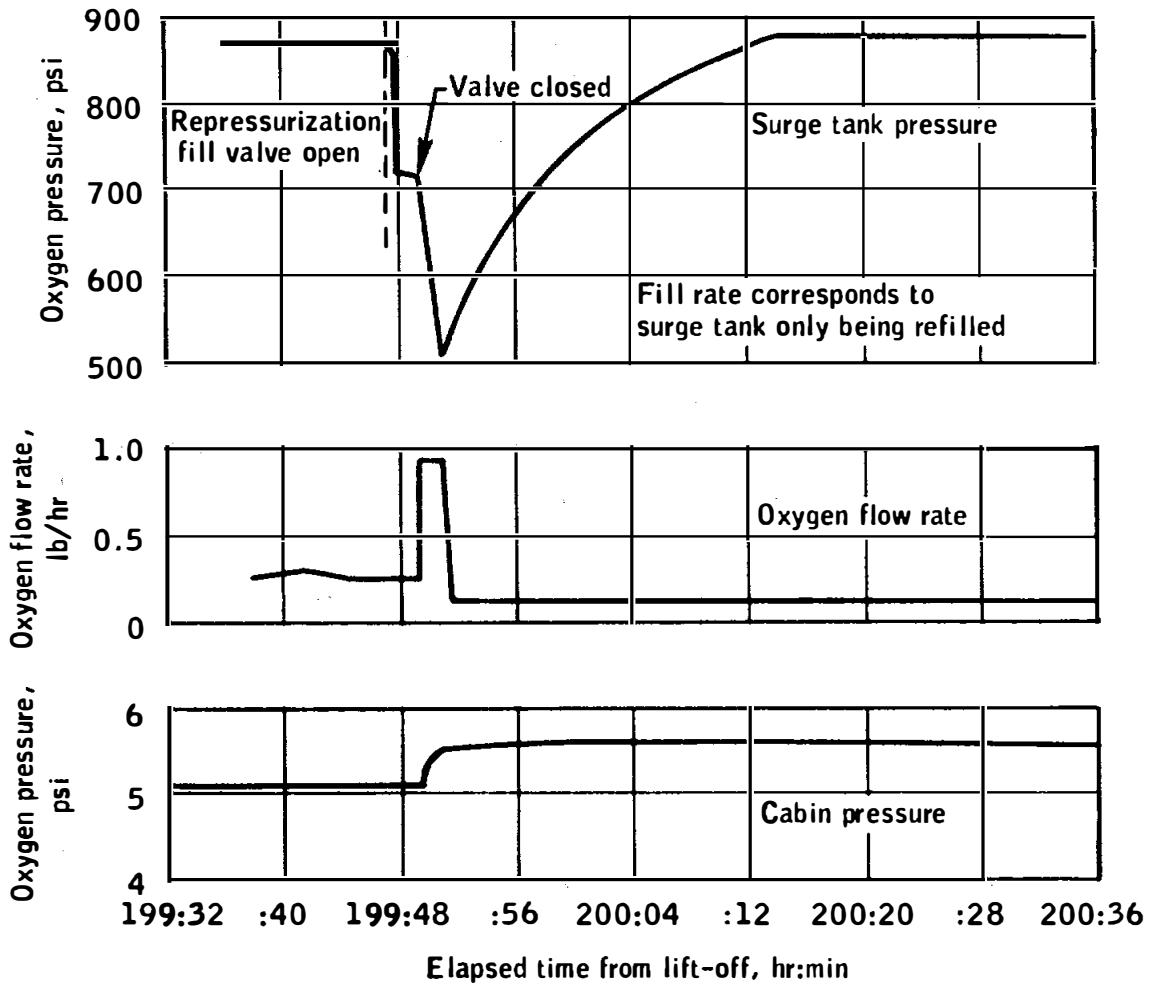
Figure 14-13.- Rapid repressurization package data.

Repressurization of the three storage bottles in the rapid repressurization system (fig. 14-12) was required three times in addition to the normal repressurizations during the mission. The system required repressurization once in lunar orbit and twice during the transearth coast phase. Just prior to the first of the transearth coast repressurizations, the system had been used (face mask checks) and refilled (fig. 14-13). In this instance, the fill valve was closed before the system was fully recharged. Calculations from the surge tank pressure data indicate that the repressurization package was at approximately 510 psi at 199 hours 48 minutes and was only recharged to about 715 psi (fig. 14-13). The cabin indication of the repressurization package pressure would have indicated a higher pressure because of the temperature rise of the compressed gas. The crew noted a value of about 700 psi (due to temperature stabilization) at approximately 211 hours and recharged the system again.

Data are not available from the lunar orbit repressurization as the spacecraft was on the back side of the moon during the operation. However, the general procedure used during the transearth coast phase would only partially recharge the system.

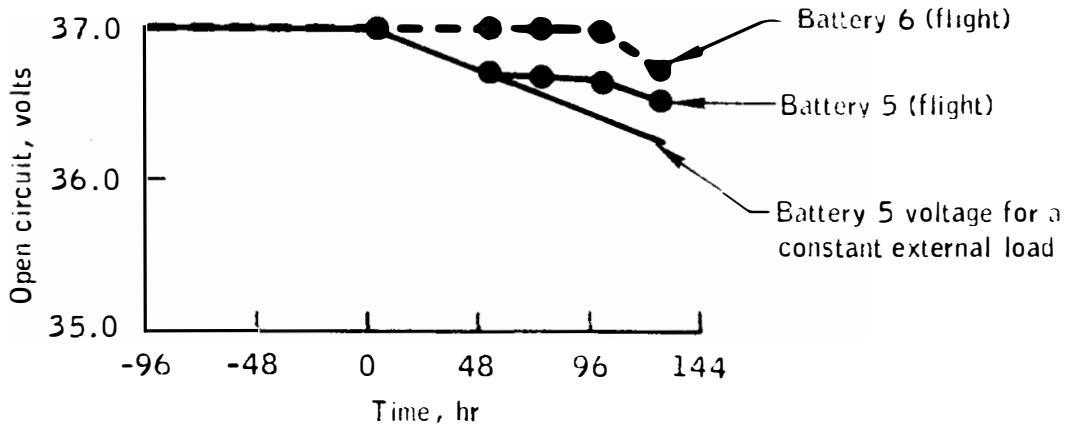
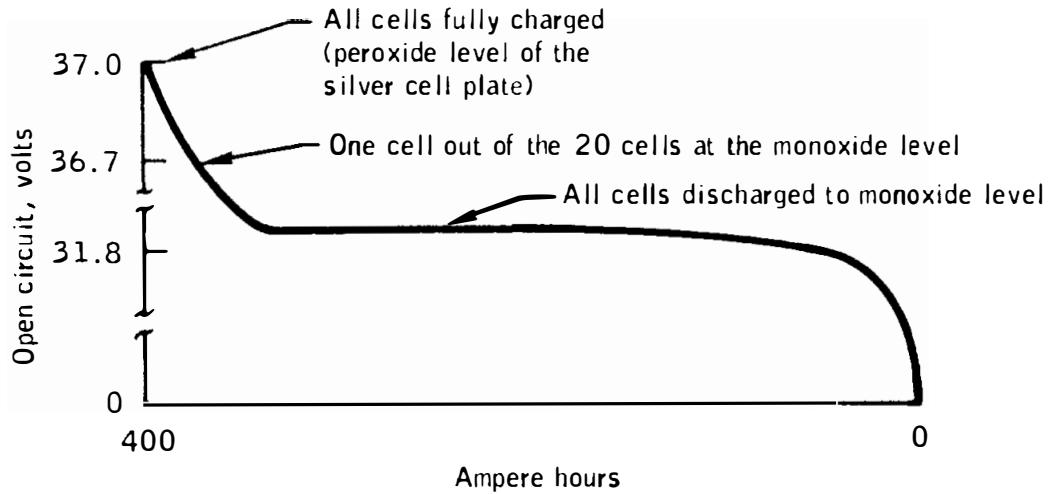
Figure 14-14.- Ascent battery voltage characteristics.

At 62 hours, the ascent battery 5 open-circuit voltage had decreased from a lift-off value of 37.0 volts to 36.7 volts instead of remaining at a constant level (fig. 14-14(a)). Figure 14-14(b) shows characteristic open-circuit voltages for a fully charged battery (peroxide level of all cells) and all cells operating on the monoxide level of the silver plate. Note that one cell at the monoxide level and the remaining 19 at the peroxide level would have caused the observed open-circuit voltage of 36.7 volts. Any one of the following conditions could have caused the voltage drop.

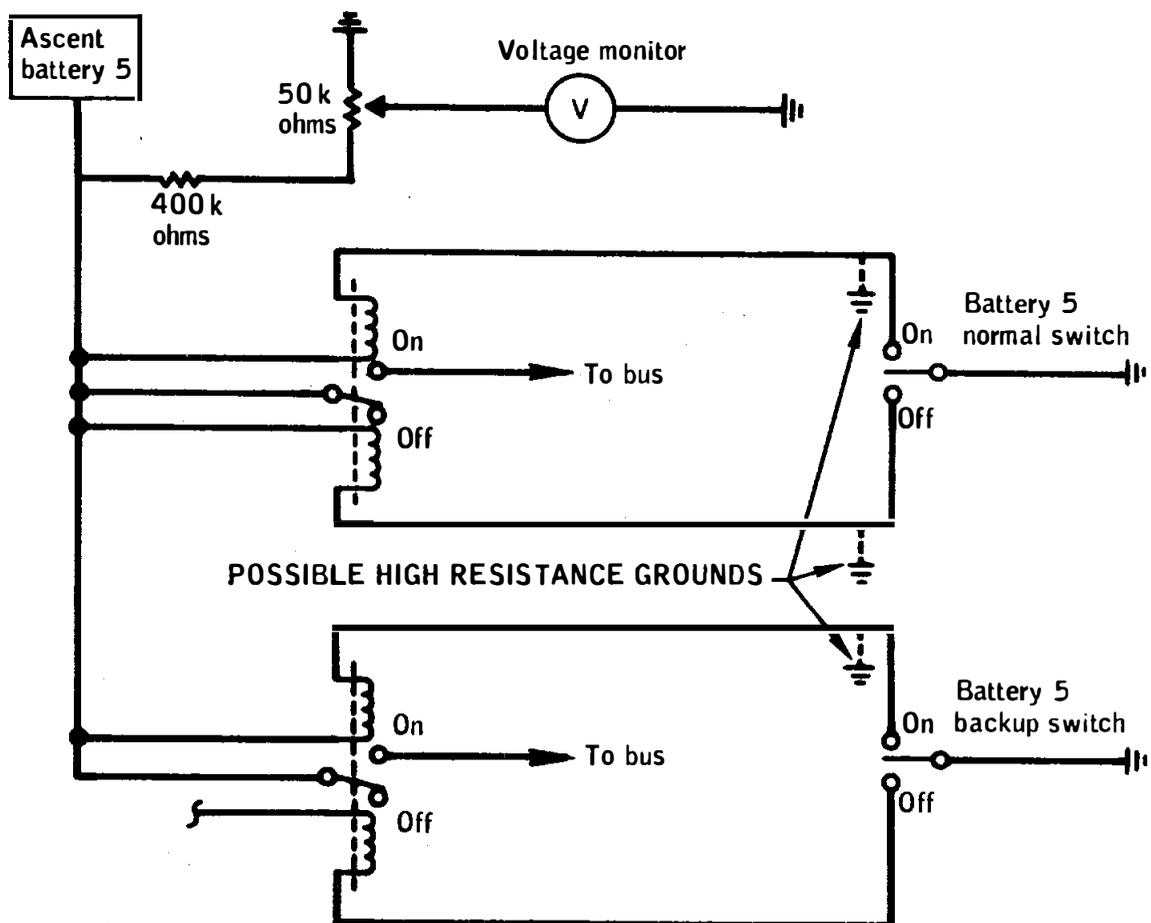
Figure 14-16.- Ascent battery 5 configured for open-circuit loads.

An external battery load could have existed from lift-off to 62 hours on the circuit shown in figure 14-16 in which typical types of high resistance shorts are also shown. For this condition, the current drain would have occurred on all cells. Figure 14-14 shows the time history of the

open-circuit bus voltage for battery 5. For a constant external load, the battery 5 open-circuit bus voltage would have been lower than the flight data at 141 hours. Therefore, the external load would have had to change with time.

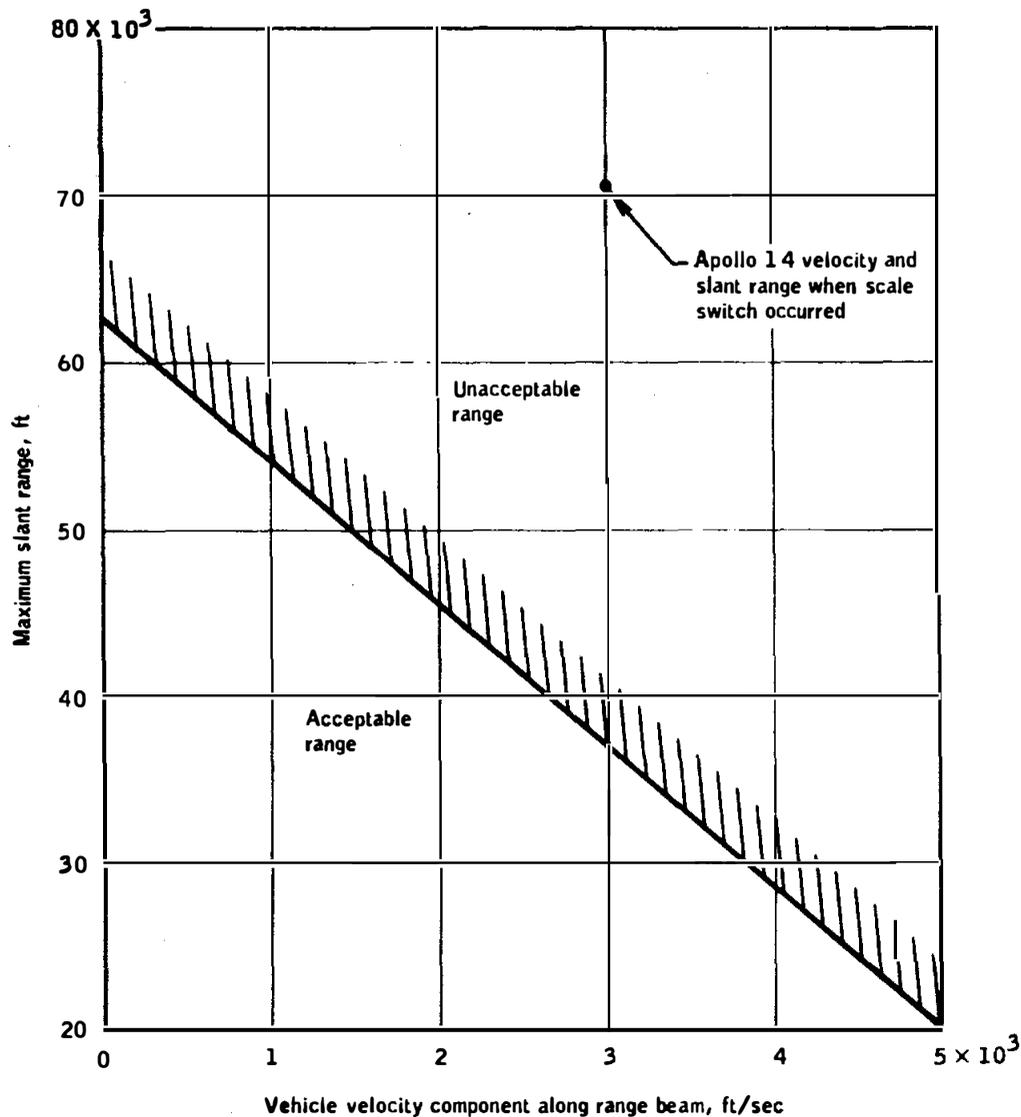
Figure 14-23.- Landing radar range measurement design limitation as a function of vehicle velocity component along range beam.

The scale switching occurred at a slant range of 63 000 feet with a beam velocity of 3000 ft/sec at an incidence angle of 35.4 degrees. Operating the landing radar under these conditions exceeds the maximum range measurement design limit (fig. 14-23). Under these conditions, the receiver is sweeping with maximum gain and the system will be sensitive to any received noise. A test was performed with a radar operating under the Apollo 14 conditions (two range-rate beams locked up and the range beam unlocked). By inserting low-level noise for a fraction of a second into the receiver, range scale switching occurred.

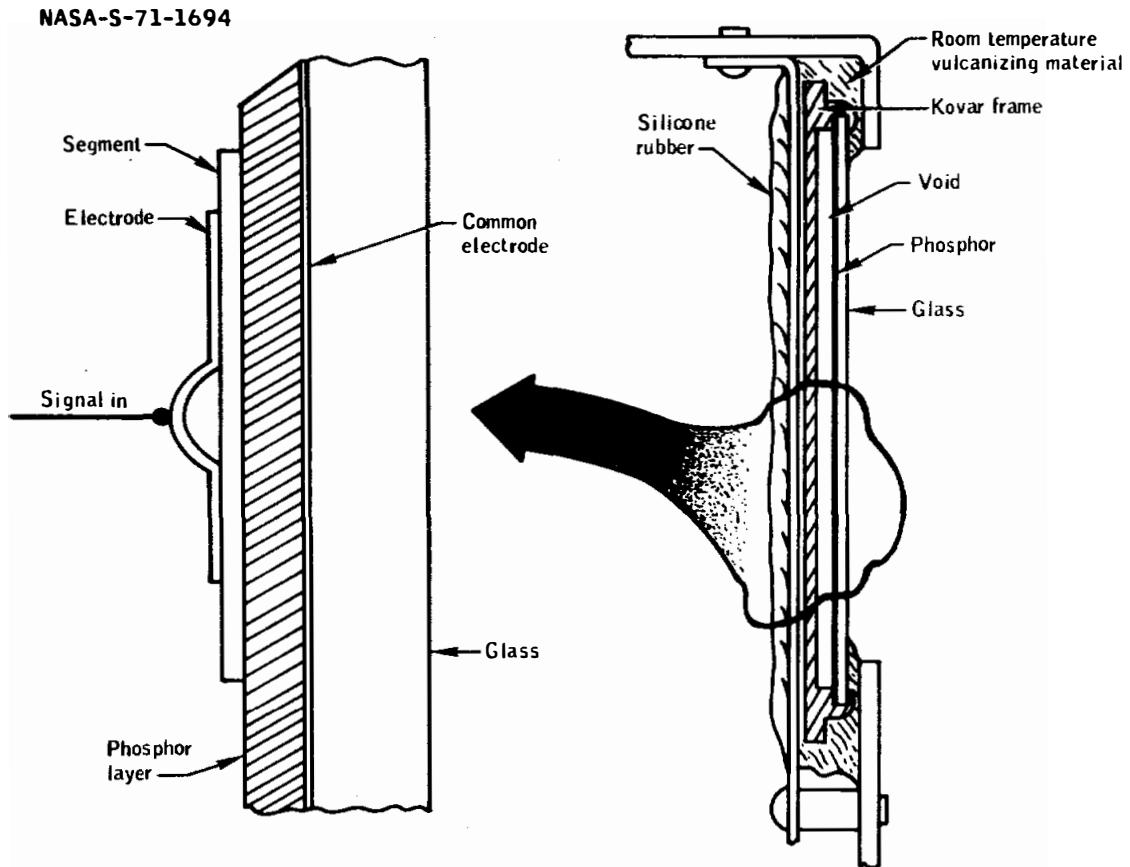
Figure 14-26.- Cross section of data entry and display assembly glass.

The crew reported a crack in the glass across the address register of the data entry and display assembly. Figure 14-25 shows the assembly and the location of the crack. Figure 14-26 is an enlarged drawing of the glass and associated electroluminescent segments.

The cause of the crack is unknown. Glass cracks have not occurred since a revision was made to the procedure used to mount the glass to the faceplate of the data entry and display assembly. The assembly is qualified for an environment in excess of the flight conditions. Therefore, either excessive internal stresses (under normal conditions) were built into the glass, or the mounting was improper (not as designed), or the glass was inadvertently hit.

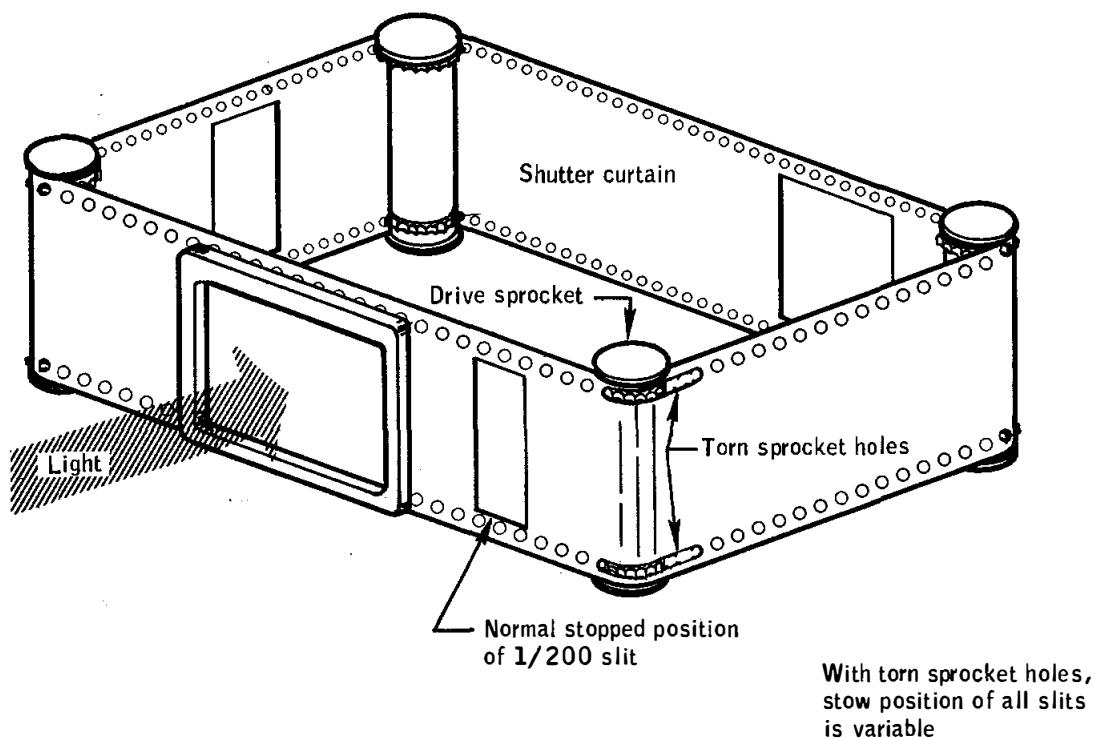
NASA-S-71-1696

loose piece of aluminum 0.130 inch by 0.008 inch, which was foreign to the transistor material. With a shorted transistor, 28 volts is applied continuously to the shutter drive circuit, causing continuous shutter operation, independent of the intervalometer and independent of the single, auto, or standby mode selections. The sprocket holes in the 1/200 slot in the shutter curtain were torn as a result of the prolonged, continuous, high-speed shutter operation (fig. 14-28).

Figure 14-28.- Lunar topographic camera film track.

The transistor had been passed by normal high reliability screening and by premission and postmission system acceptance tests operating under vibration, thermal, pressure, and humidity conditions; none of which detected the piece of aluminum. Additional screening being considered for future applications includes the use of N-ray and acoustic inspection. An occurrence of this nature is rare, but it is even rarer for such a condition to pass the high reliability screening.

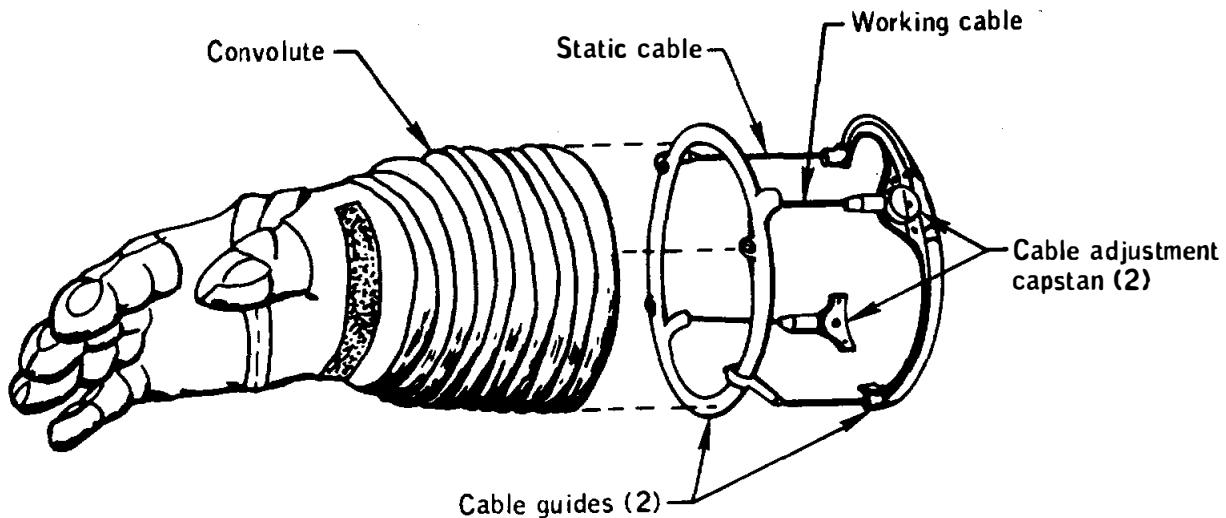
NASA-S-71-1697

After suit pressurization for the second extravehicular activity, the Lunar Module Pilot reported that his right glove had pulled his hand to the left and down and that he had not had this trouble during the first extravehicular activity period. The condition was a nuisance throughout the second extravehicular activity period. Initial indications from the Lunar Module Pilot were that a cable had broken in the glove (fig. 14-29).

Figure 14-29.- Extravehicular glove wrist control.

A detailed examination of the returned glove, together with chamber tests, have shown that there are no broken cables and that there is free operation of the glove wrist-control cable system. However, with the Lunar Module Pilot in the pressurized flight suit, the glove took the position which was reported during the mission.

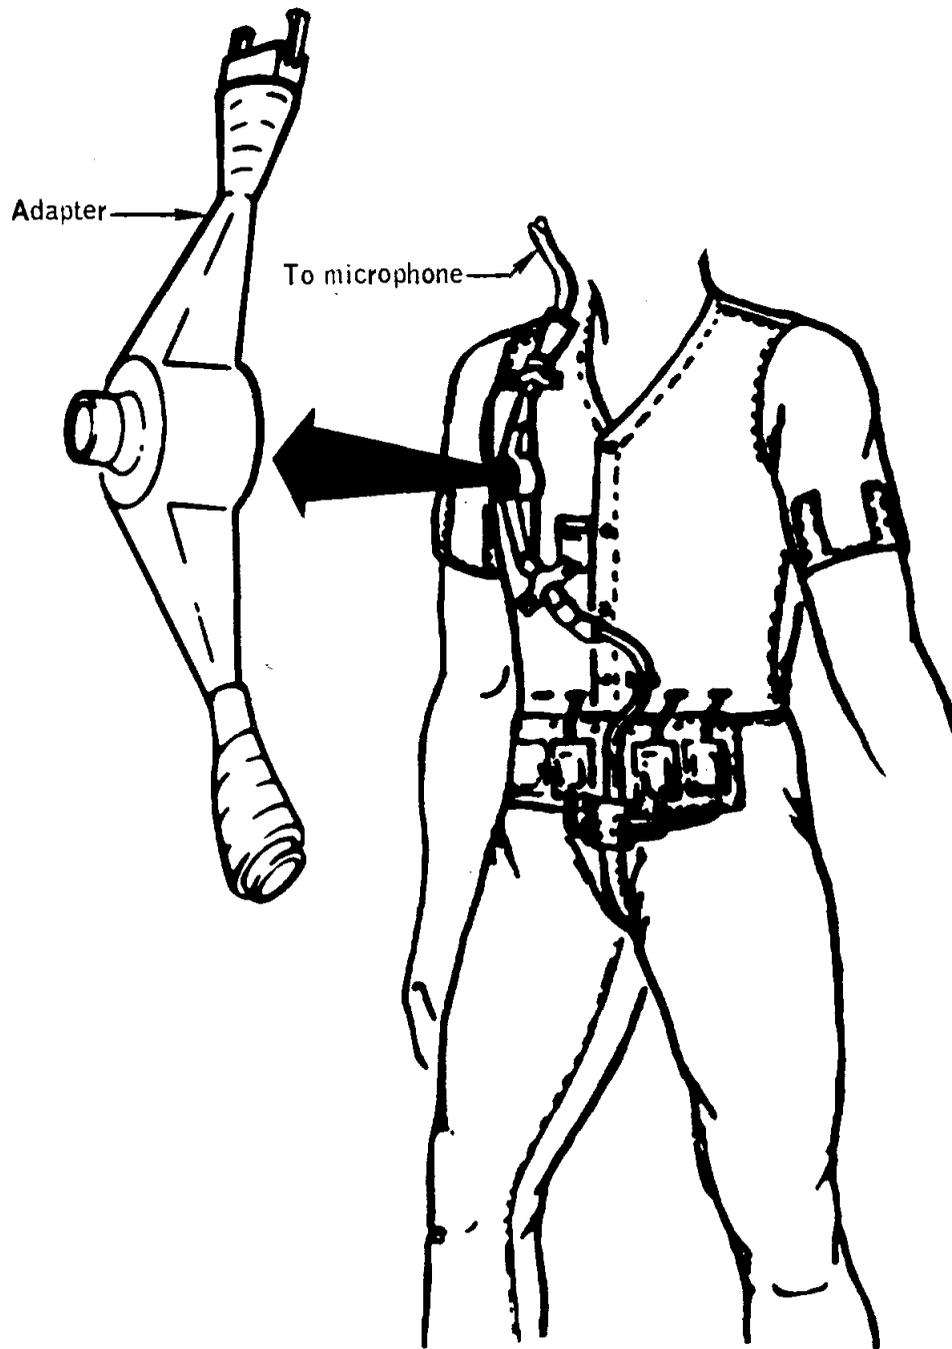
NASA-S-71-1698

At approximately 29 hours, Mission Control had difficulty in communicating with the Commander. The Commander replaced his constant wear garment electrical adapter (fig. 14-30) with a spare unit, and satisfactory communications were reestablished.

Following release of the hardware from quarantine, all four constant wear garment electrical adapters were tested for continuity and resistance, and all units were satisfactory. The adapters were then

Figure 14-30.- Constant wear garment communications harness.

connected to a portable communications set which provided conditions similar to flight conditions. While connected, the adapters were subjected to twisting, bending, and pulling. None of the adapters showed any electrical intermittents.

The most likely cause of the problem was poor contact between connectors because of small contaminants or improper mating of a connector, which was corrected when the spare adapter was installed.

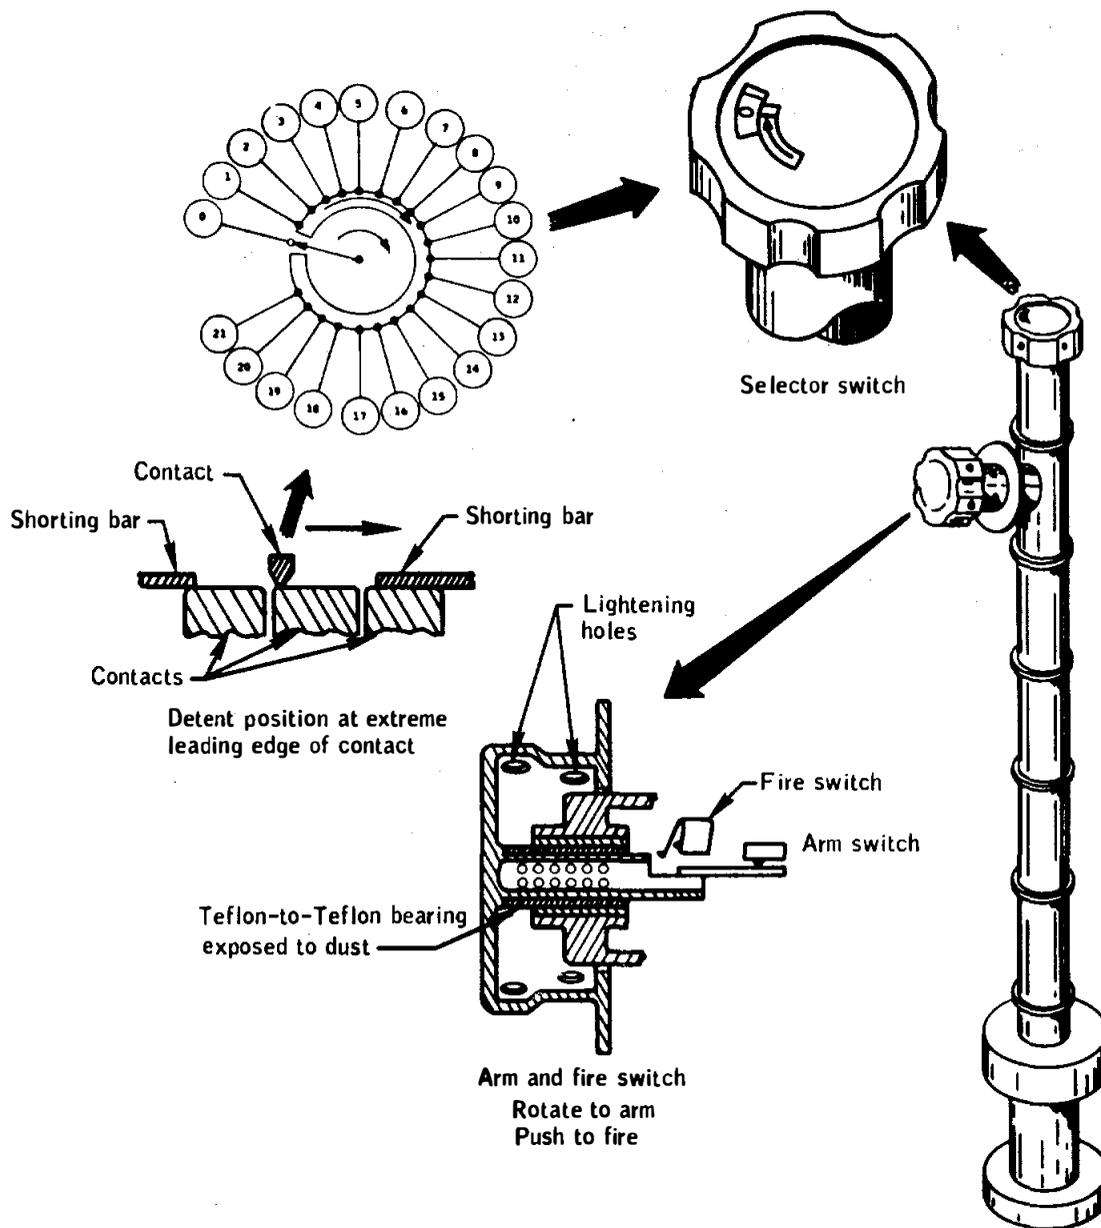
NASA-S-71-1699

The most likely causes of the problem are associated with the detent portion of the selector switch (fig. 14-31) and dirt on the firing switch actuator bearing surface. The selector switch dial can reposition out of detent in the course of normal handling because of the lack of positive seating in the detent for each initiator position. For an initiator to be fired, the selector switch must provide contact to the proper unfired initiator position. Examination of the qualification unit has shown that the detent is positioned at the leading edge of the contact surface so that any movement toward the previous position will break the contact. Also, the lightening holes in the firing switch knob make it possible for dirt to get onto the Teflon bearing surfaces, temporarily increasing the force required to close the switch (fig. 14-31).

Figure 14-31.- Active seismic experiment.

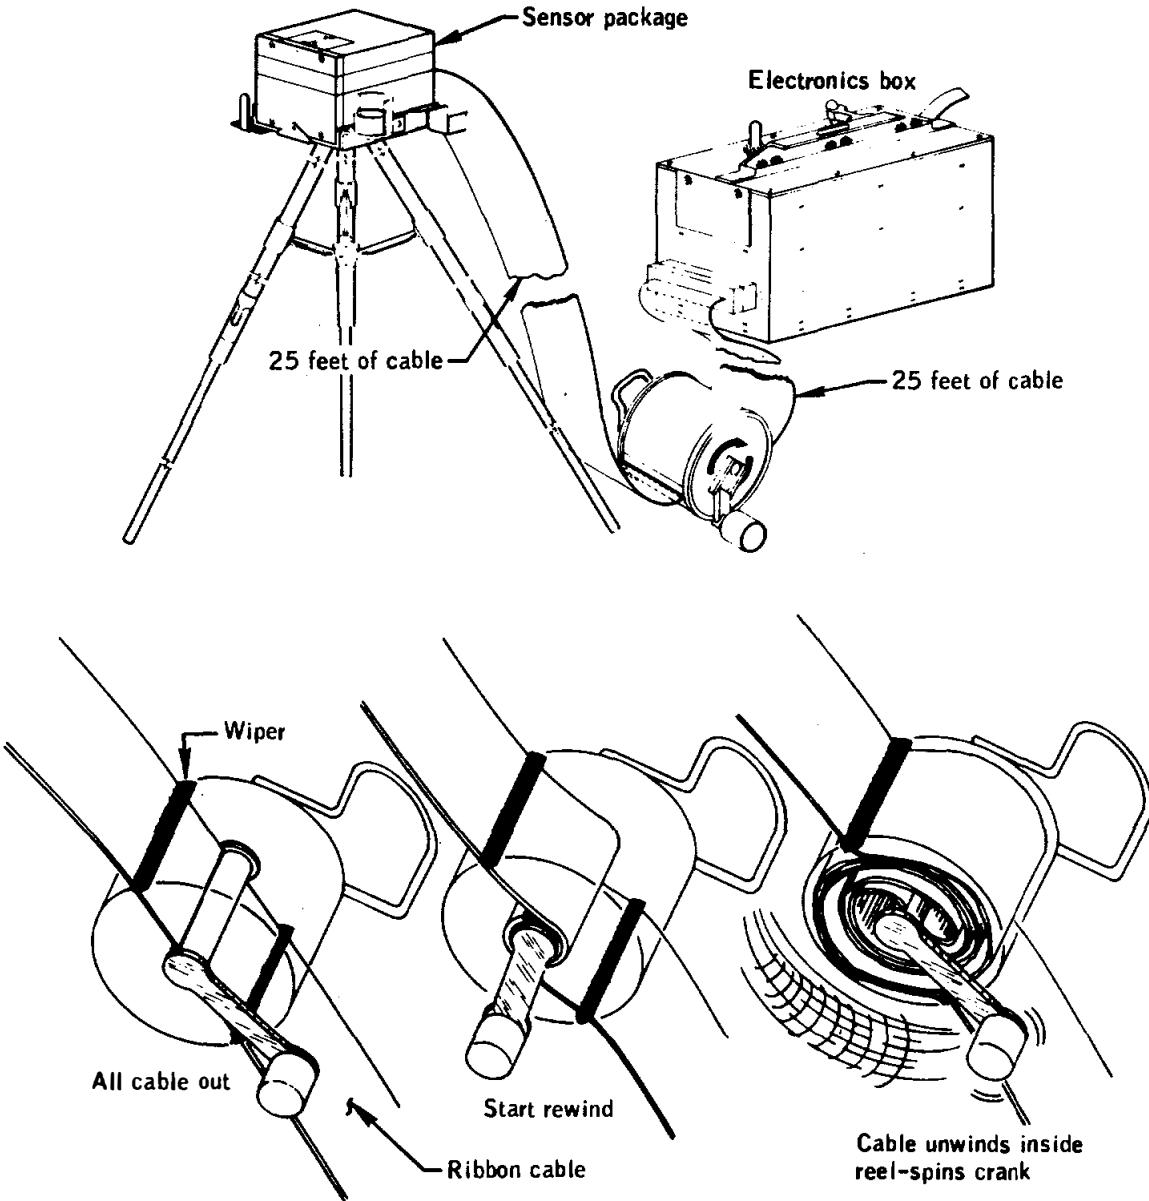
NASA-S-71-1700

The crew reported that it was difficult to rewind the lunar portable magnetometer cable. The cable is deployed and rewound at each location where the lunar portable magnetometer is used (fig. 14-32).

Figure 14-32.- Lunar portable magnetometer cable reel.

The lunar portable magnetometer ribbon cable snarls easily at 1/6g and is difficult and tedious to unsnarl. If it is necessary to remove the hand from the crank to unsnarl the cable during the first part of rewinding the cable, the cable will unwind within the reel and spin the reel handle (fig. 14-32). Free unwinding of the reel is required during deployment; however, it is desirable to be able to lock the reel against rotation at times during rewind of the cable. Rewinding was difficult because there was no provision to lock the reel during rewind, and gripping the reel and crank was difficult with the gloved hand.

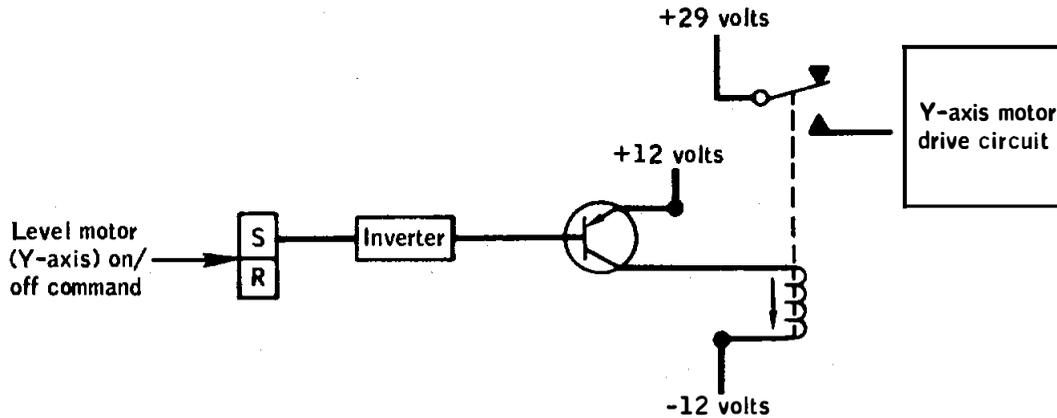
NASA-S-71-1701

The horizontal Y-axis leveling motor of the gimbal leveling system operates intermittently (fig. 14-33). Although a command verification is received when commands are sent, power is not necessarily received by the motor. When there is an indication of power to the motor, the motor does operate. As a result, during the first lunar day, response to ground commands was normal except for 6 of the 22 commands when there was no response.

Figure 14-33.- Y-axis leveling motor circuitry.

Although no scientific data have been lost to date, intermittent problems have been encountered when leveling the Y-axis of the gimbal platform upon which are mounted the three orthogonal long-period seismometers. Occasionally, either there is no electro-mechanical response, or the response is delayed when the Y-axis motor is commanded on. Delay times vary. Thus far, leveling has been achieved by cycling on/off commands at varying time intervals.

The problem is caused by an intermittent component in the motor control circuit (fig. 14-33). There is no correlation between the occurrence of the problem and the temperature of the lunar surface, the central station electronics, or the experiment. Whenever there is an indication of power to the motor, the motor operates. When the motor operates, it operates properly and pulls the normal current.

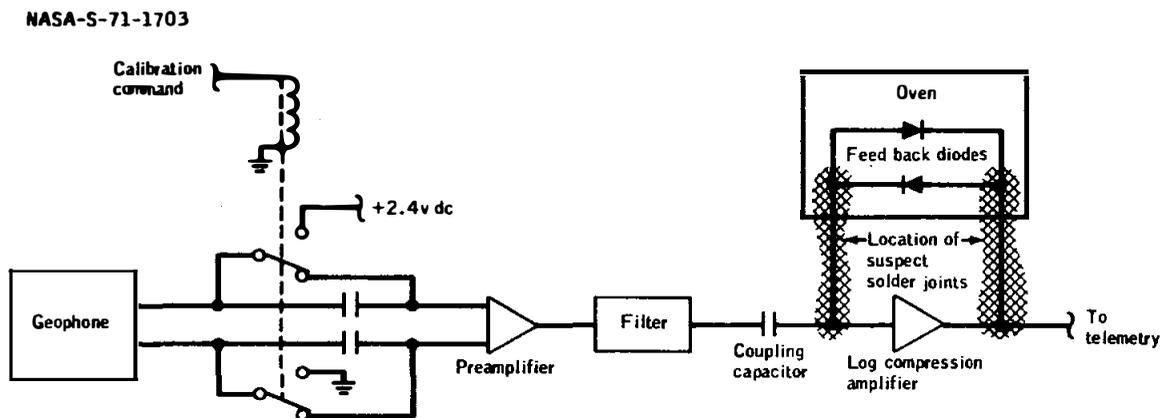
As shown in figure 14-35, each geophone channel consists of a geophone, an input preamplifier, a low-pass filter, and a logarithmic compressor amplifier. The output of the logarithmic compressor feeds the instrumentation system. The logarithmic compressor is basically an inverting amplifier with exponential negative feedback. Two diode-connected transistors between the output and input of the amplifier supply the feedback. The first diode is used for positive-going and the second for negative-going input signals. The diodes for all three geophone channels (two per channel) are physically located in an oven which controls their temperature at 105° C.

Figure 14-35.- Typical geophone channel.

It is believed that the failure is in the logarithmic compression amplifier because signals are coupled into it through an input coupling capacitor. This capacitor would block any offset voltages from the preceding stages which would be required to drive the output off-scale high. Analysis indicates that the most probable cause of the problem is an intermittent open circuit in the diode feedback path. This would allow the amplifier input transistor to saturate, driving the output off-scale high. When signals large enough to drive the input stage out of saturation were present, the output would then respond and the output signal would not be compressed.

The experiment electronics uses "cordwood" construction of the type which has caused solder cracks in other equipment. Two copper paths conduct the feedback diodes to the logarithmic compressor amplifier. A solder crack in either path would then result in the data characteristics.

A breadboard of the logarithmic compressor has been constructed, and the diode feedback loop will be opened to duplicate the experiment data. The mechanical design of the logarithmic compressor will be reviewed to determine the changes that must be made to prevent solder cracks on Apollo 16. The active seismic experiment is not carried on Apollo 15.

Procedural changes under consideration include operation of the oven to maintain compressor module temperature because the solder joint which is most likely cracked is in compression (stronger) at the higher temperature.

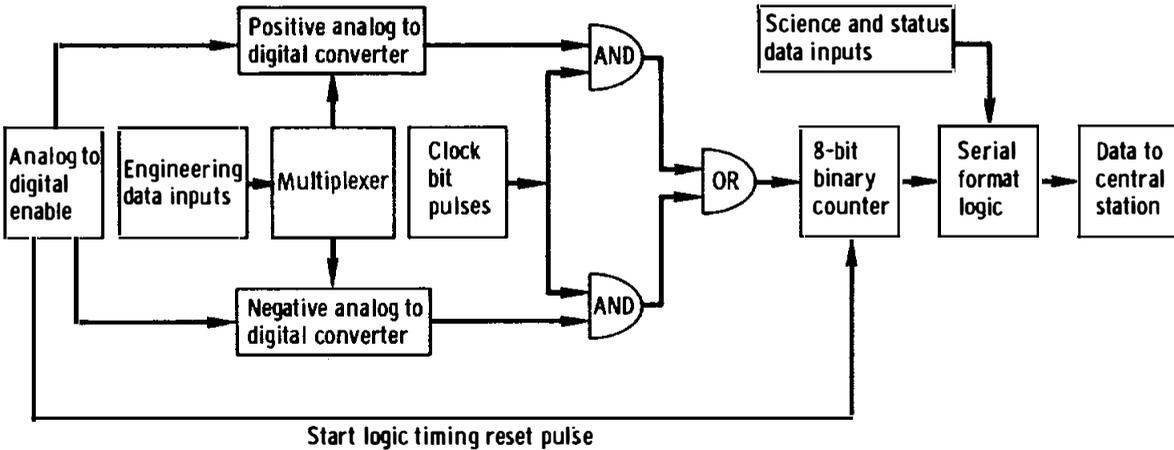
NASA-S-71-1705

An intermittent failure of the start reset pulse for the positive log analog-to-digital converter control logic (fig. 14-37) could cause the problem. Although the failure permits the positive converter initial output to fill the eight-bit binary counter and produce a full-scale reading; thereafter, when a start pulse for the positive converter should reset the eight-bit counter, it fails to do so, and the negative word which is still in the counter is read out as a positive word. The cause appears to be an intermittent component or wire connection in one of the associated modules. However, it does not appear to be a function of the temperature. The components have been passed by normal high reliability screening, and systems tests have included operational pressure, temperature, vibration, humidity, and accelerated lunar environment cycles. No failure of this

Figure 14-37.- Simplified data logic control.

type has been experienced with ground tests. No additional testing is considered warranted for Apollo 15, which will be the last mission for the experiment.

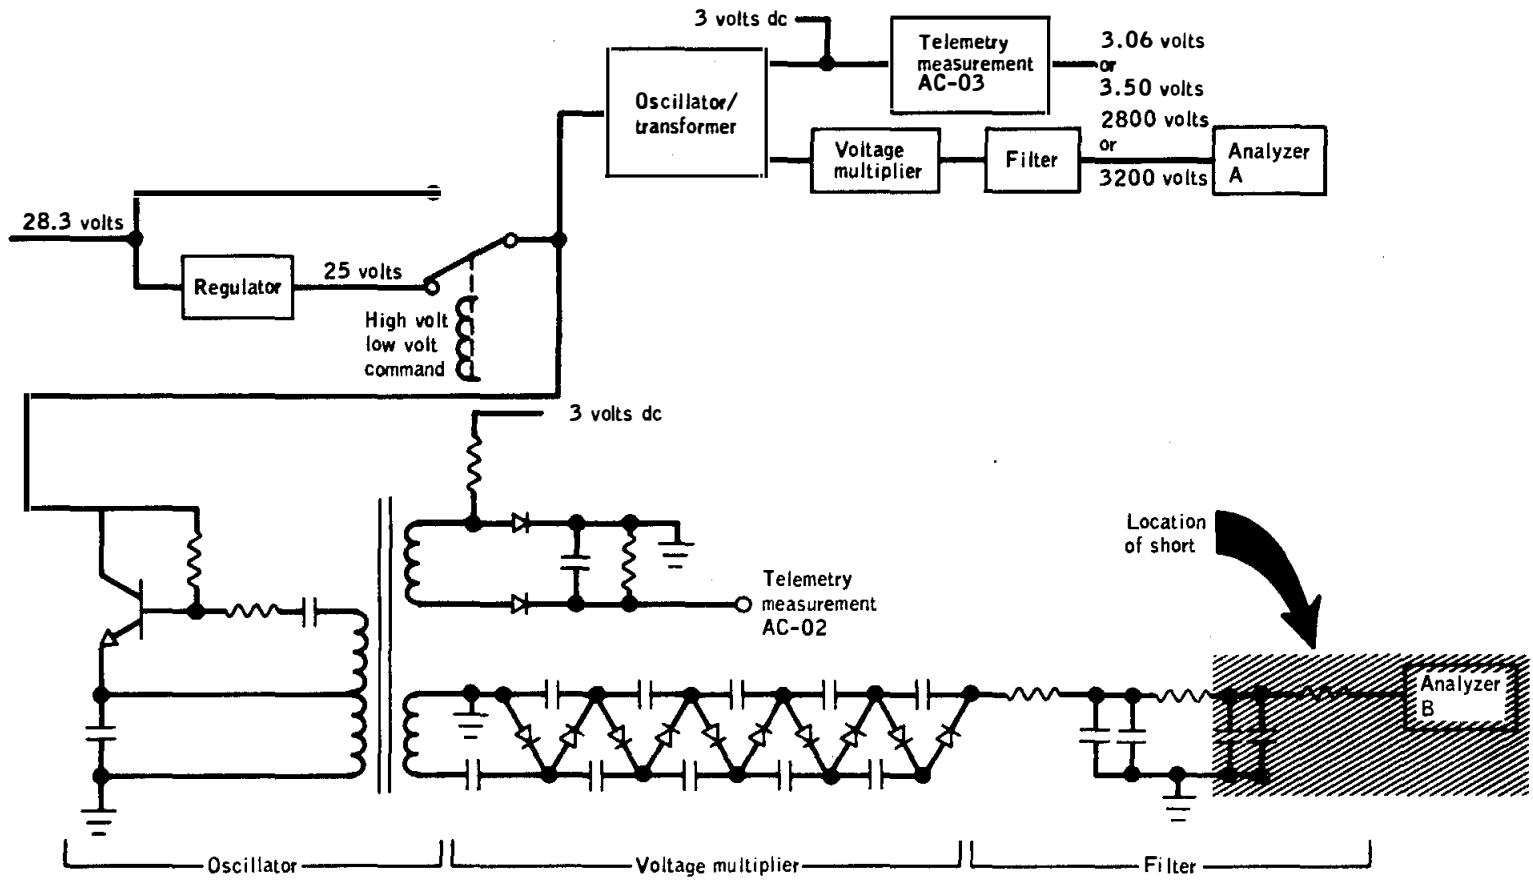
The voltage measurement reading on the analyzer B power supply (fig. 14-38) became erratic on April 8, 1971, and the analyzer B science data were lost.

On April 10 and 16, the experiment was commanded on to normal (low-voltage) mode, and to increase (high-voltage) mode in a series of tests. The results indicate that the plus 28-volt input, the regulator, and the analyzer A power supply were functioning properly, and that the problem was in the analyzer B power supply.

Figure 14-38.- Analyzer power supplies.

Data indicated that after the failure occurred, the instrumentation output was between 2.00 and 2.25 volts dc. This could not occur if the oscillator were not still oscillating. The input to the voltage multiplier is also proportional to the instrumentation output. Shorts to ground can be postulated at various points in and downstream of the voltage multiplier, and the short circuit current can be reflected back into the transformer primary winding to determine how much the output voltage should be decreased. The decrease occurs because the transformer primary winding (the driving winding) has resistance (about 300 ohms), and any voltage dropped across this resistance is not available to drive the transformer.

This is the last time the charged particle lunar environment experiment will be flown. If the failure propagates to the point where the malfunctioning power supply stops oscillating, the current taken by this supply would increase to about 0.1 ampere. If this is sufficient to damage the series voltage regulator used for low-voltage operation, the operating procedures will be modified to use low-voltage operation as little as possible to extend the voltage regulator's life.
